Inspection Report

LIGHTHOUSE HOME INSPECTIONS

, 1002 Peninsula Road, , Ucluelet, BC, V0R 3A0

Inspection prepared for: Terrace Beach Resort

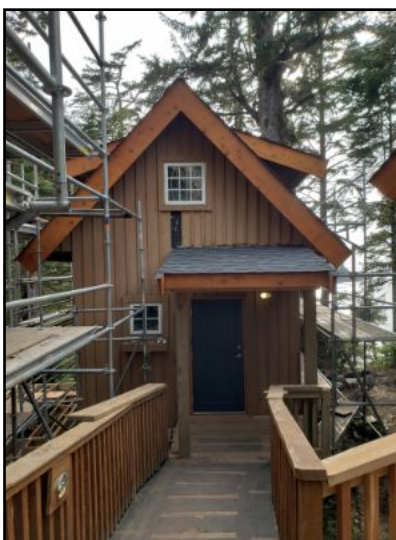
Cedar siding with required building paper noted under siding. Still under construction at time of inspection, almost done.

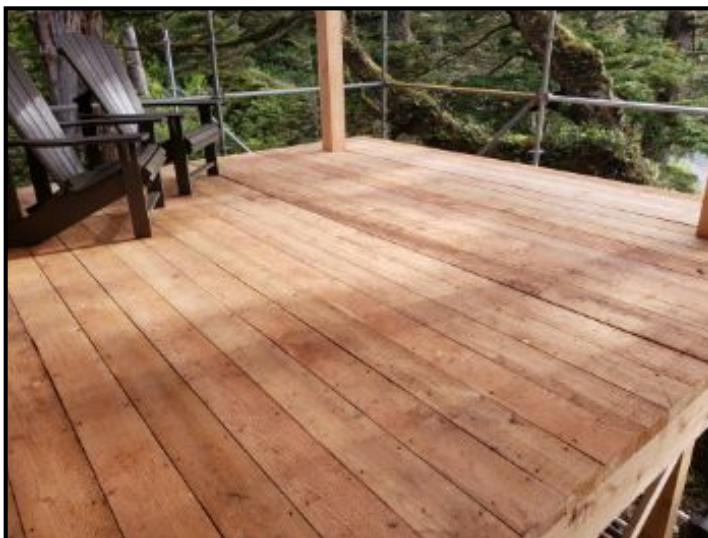
Joist have been constructed, cedar decking is yet to be installed on lower, top deck is complete.

- Deck railing to be completed with tempered glass and aluminum rails.
- Joist have been constructed, cedar decking is yet to be installed.

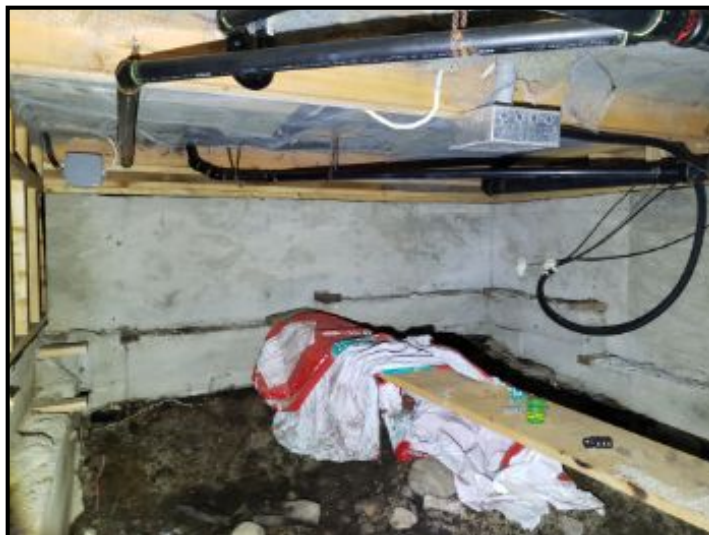
Rodent droppings noted in crawlspace.

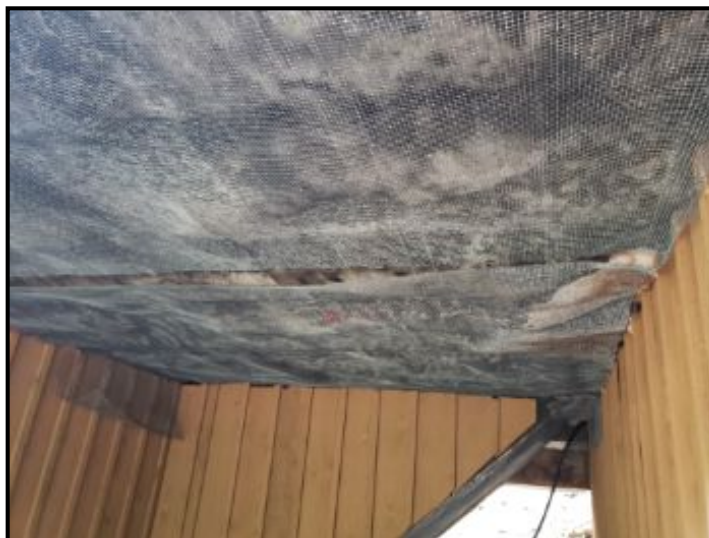
Keep underside of home well sealed.

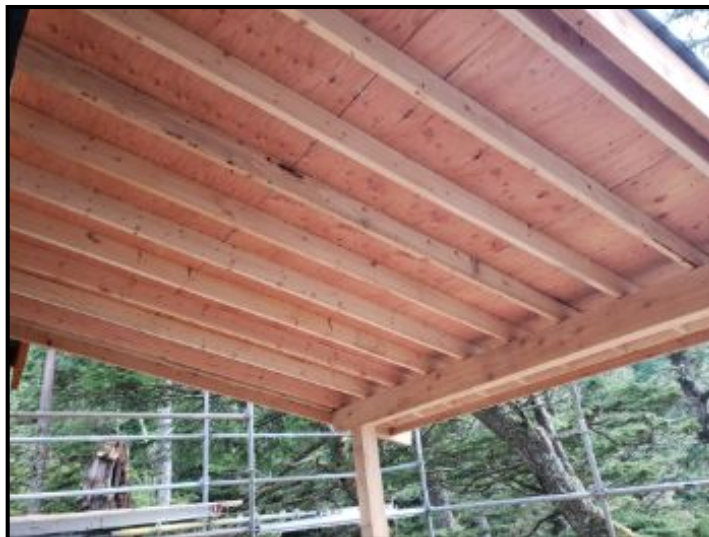
All new joists and plywood for rear roof over deck.

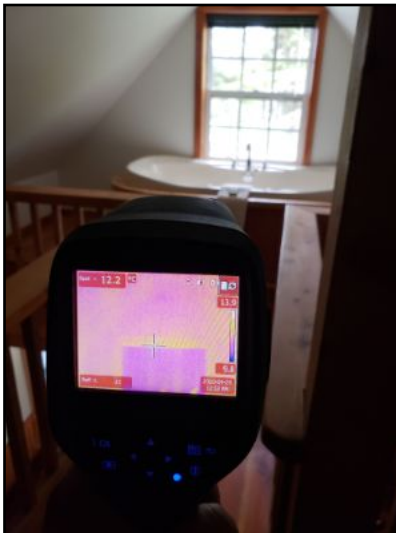
Thermal camera used to check insulation in finished spaces, no voids noted.

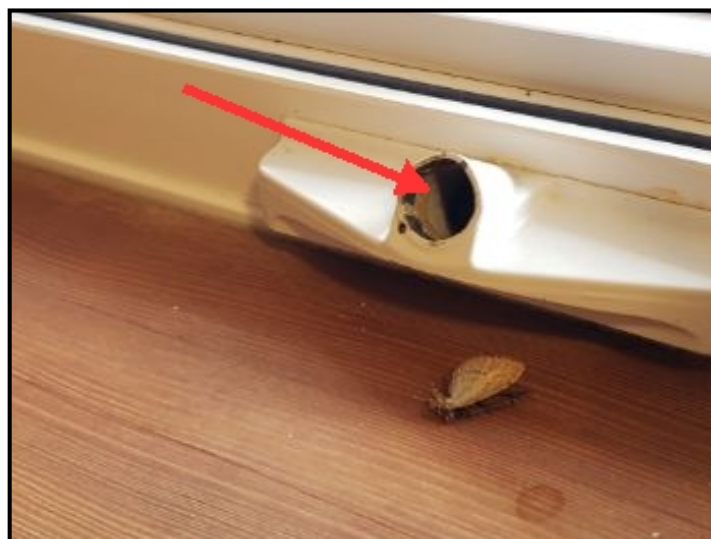
Damaged window hardware upstairs.

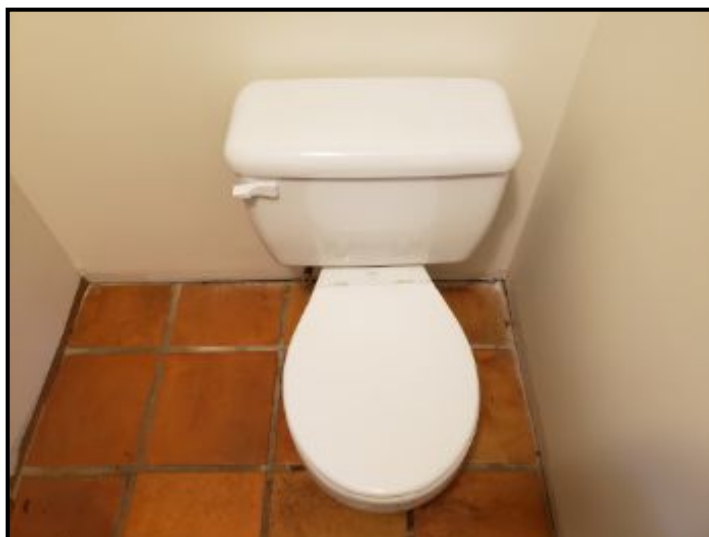
Washroom has loose toilet. Have repaired to prevent future leaking at wax seal.

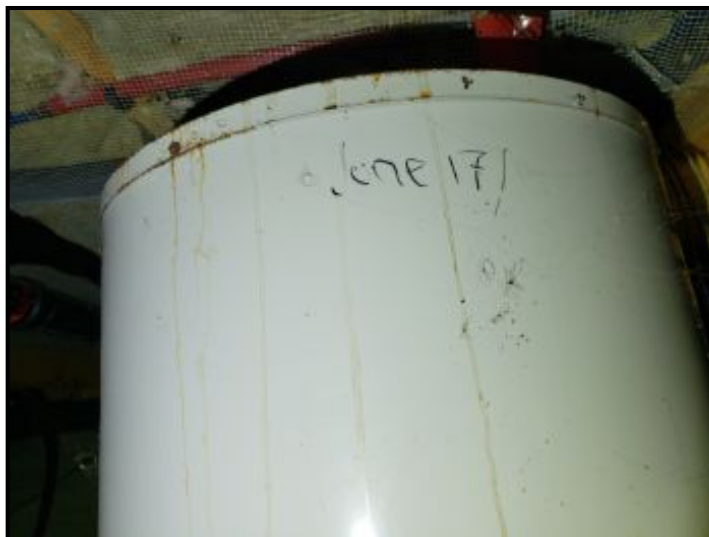
Plumbing		
Page 12	Water Heater Condition	• Tank is rusted, damaged and/or leaking. Replacement recommended.

Tank is rusted, damaged and/or leaking. Replacement recommended.

- Add insulating wrap to hot water tank as it sits in a cold space.
- Tank is rusted, damaged and/or leaking. Replacement recommended.

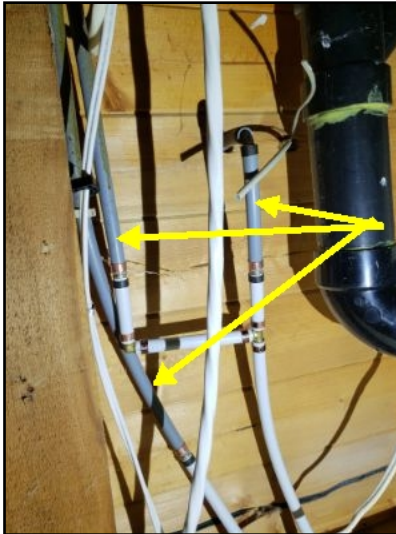
Poly'B' plumbing with copper collars and fittings may not be acceptable to all insurance providers

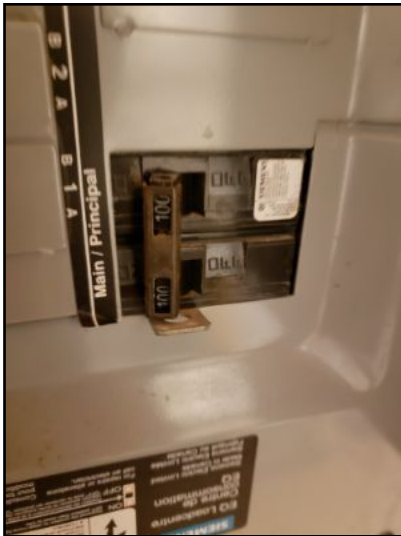
100 amp service with all copper branch wiring.

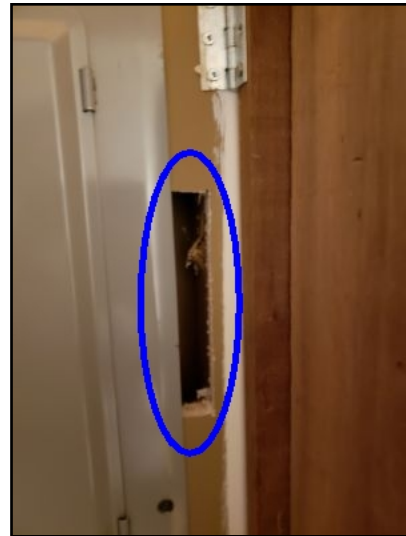
Cover open cut out beside panel for safety.

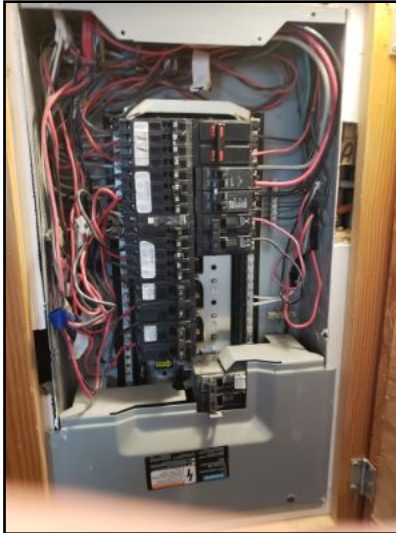
Panel was opened and all wiring appeared to be in good order. Install was fairly clean.

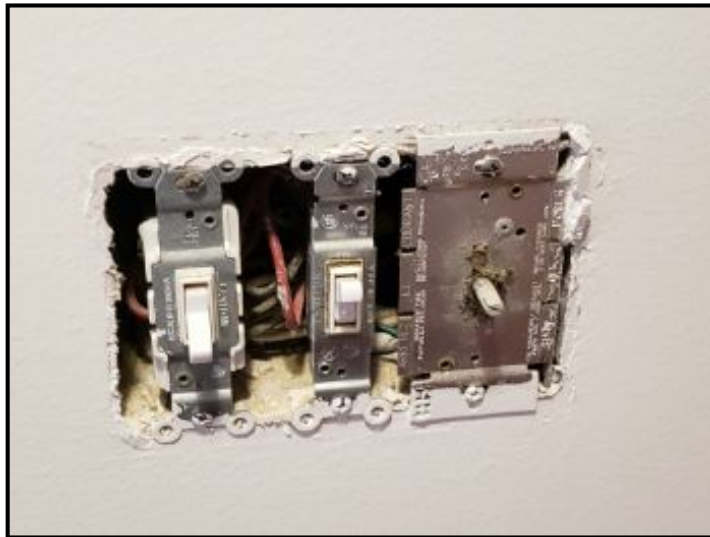
Some outlet covers have been removed for paint. They will be re-installed afterwards.
